Dominion SX R3.1 Technical Bulletin

Release Date: 8 August, 2007

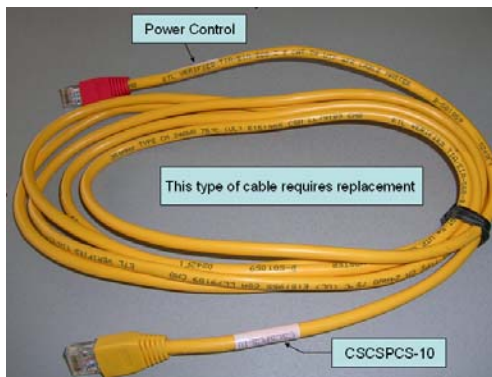
- If the label marked as "CSCSPCS-10" (close to the yellow boot) is located far from the label marked as "POWER CONTROL" (close to the red boot), the cable needs to be replaced.

Those who use the Dominion SX to manage Remote Power Control (RPC) units from Raritan may encounter a problem when upgrading to Dominion SX R3.1. The serial cable connecting the SX to the RPC unit may no longer work. This problem can be resolved by replacing the cables that connect the SX and the RPC units.

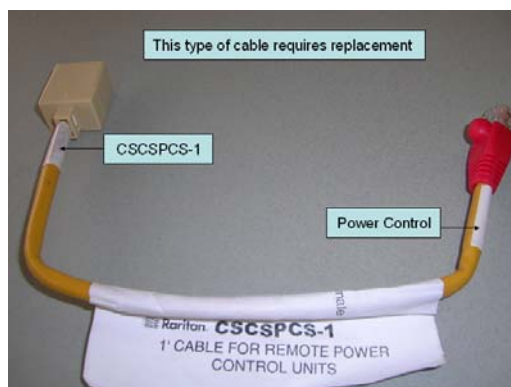
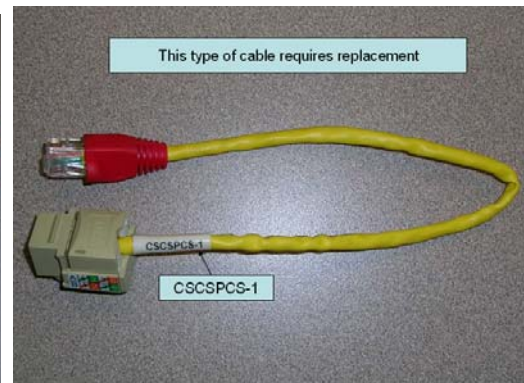
- If the label is marked as "CSCSPCS-1", the cable needs to be replaced.

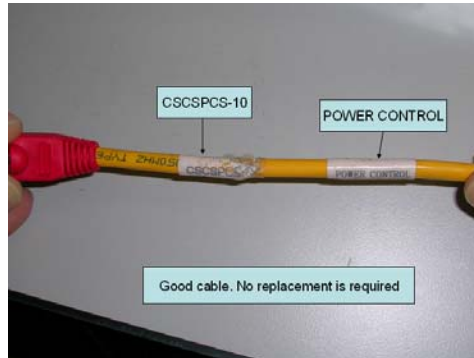
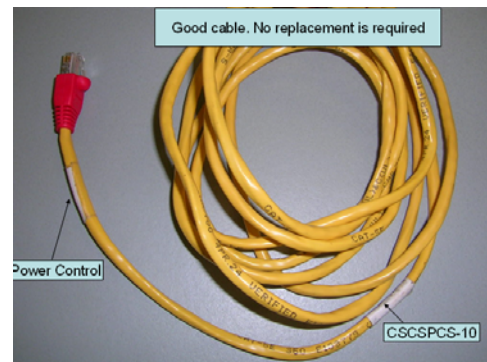
- If the label is marked as “CSCSPCS-10” and it’s placed close to another label marked as “POWER CONTROL” towards the red boot, no replacement is necessary.

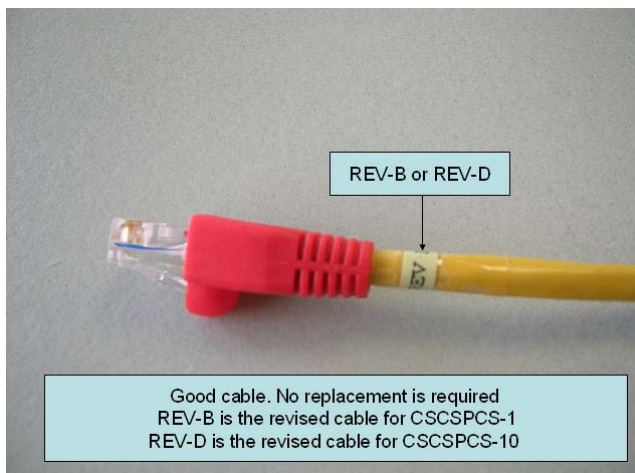
- If the label is marked as “REV B” or “REV D”, even if there is another label marked as “CSCSPCS-10” or “CSCSPCS-1”, no replacement is necessary.
