Release Notes for Dominion® PX Software Version 1.2 (firmware version will show 1.02 in the GUI after an upgrade)

Version: DPX 1.2 Release Notes, Revision 1.2

Date: September 4, 2008

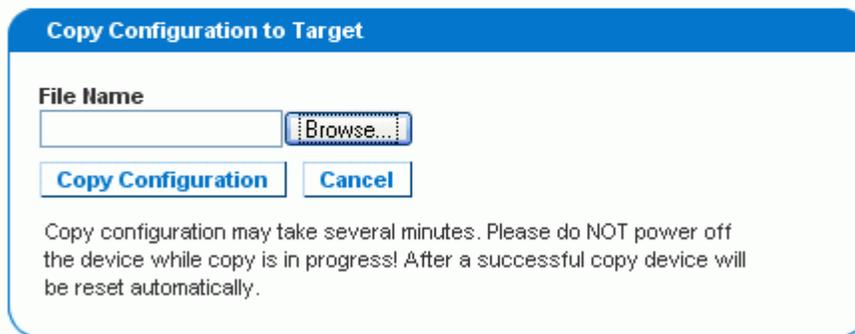
A dialog box with a blue header bar containing the text "Save Configuration". Below the header bar, there are two buttons: "Save Configuration" and "Cancel".

A dialog box with a blue header bar containing the text "Copy Configuration to Target". Below the header bar, there is a "File Name" label followed by a text input field and a "Browse..." button. Below these are two buttons: "Copy Configuration" and "Cancel". At the bottom of the dialog box, there is a paragraph of text: "Copy configuration may take several minutes. Please do NOT power off the device while copy is in progress! After a successful copy device will be reset automatically."

Copying Configurations with Bulk Configuration
