## Paragon II Platform

Release 4.4.1

August 4, 2008

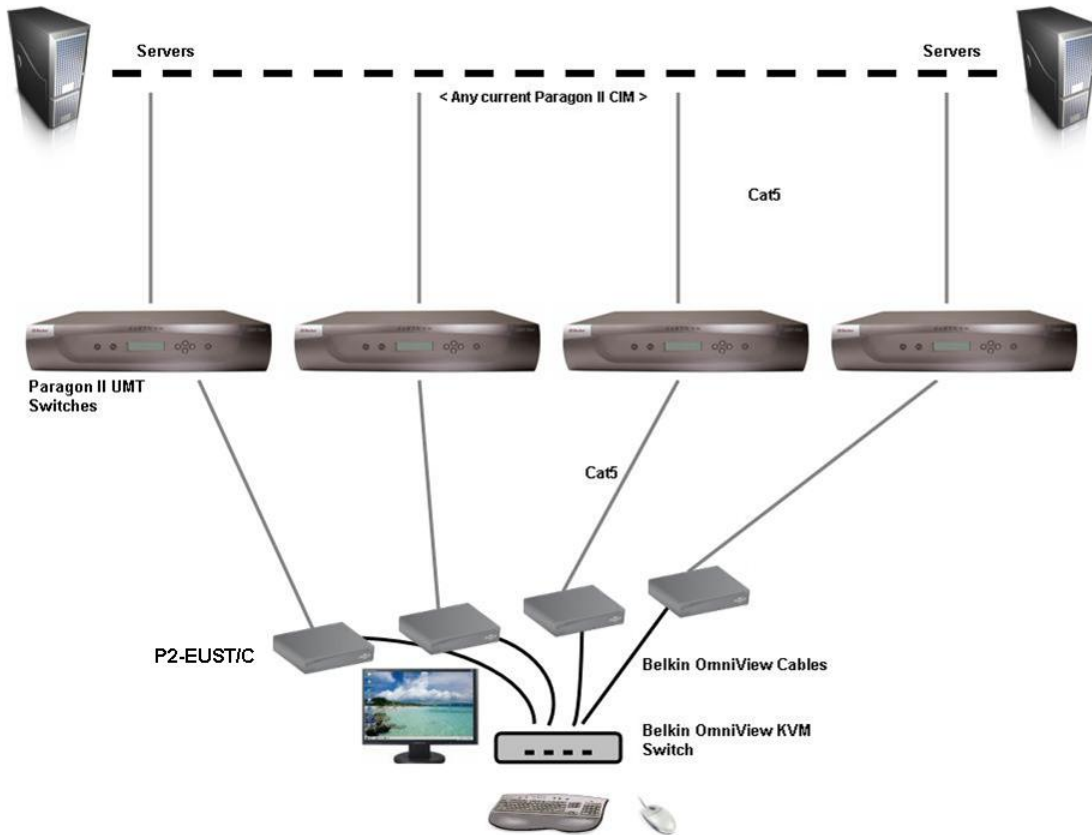
The following picture represents the supported configuration (in this example, the 4-port model is used):

Use of the P2-EUST/C card reader is supported with this configuration, however, the card must be reinserted each time a new server is accessed.
